**GEOTECHNICAL FORENSIC  
INVESTIGATION REPORT  
430 EAST 77<sup>TH</sup> STREET  
NEW YORK, NEW YORK**

**June 16, 2005**

Re: Geotechnical Forensic Investigation Report  
430 East 77<sup>th</sup> Street  
New York, New York  
MRCE File No. 10414  
Claim # 057-430-050202

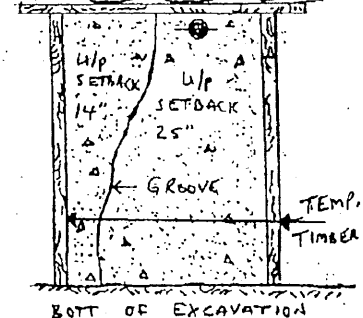
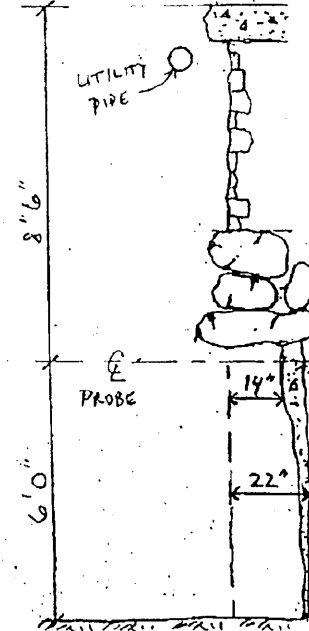
SECTION A-A

TP1 revealed that the foundation of 430 East 77<sup>th</sup> Street is constructed of cemented boulders extending to a depth of about 5.5 feet on top of un-cemented, large, irregularly-sized boulders. The bottom of the foundation wall is about 8.5 feet below the top of the 1<sup>st</sup> floor slab. The soil below the foundation is classified as a stiff silty-clay (NYC Class 9-65).

The underpinning piers installed below the foundation of the garage was exposed in test pit TP1. No form work for the underpinning piers was encountered. The concrete of the underpinning piers was found to be setback approximately 25 inches east of the face of the foundation wall on the south end of the test pit. On the north end of the test pit, the concrete of the underpinning piers was found to be setback approximately 14 inches from the face of the foundation wall (see Test Pit sketched included in Appendix A). A semi-vertical groove was observed in the concrete of the underpinning piers, indicating a possible joint between 2 underpinning piers. It appears that the excavation below the foundation for the garage was advanced without providing support of excavation. Once the excavation under the foundation of the garage reached the desired depth, formwork was placed on the garage side for the underpinning pier and concrete was placed in direct contact with the soil on the west face of the underpinning piers. The bottom of the underpinning piers was measured to be 14.5 feet below the top of the 1<sup>st</sup> floor slab, approximately 6.5 feet below the foundation of 430 East 77<sup>th</sup> Street.

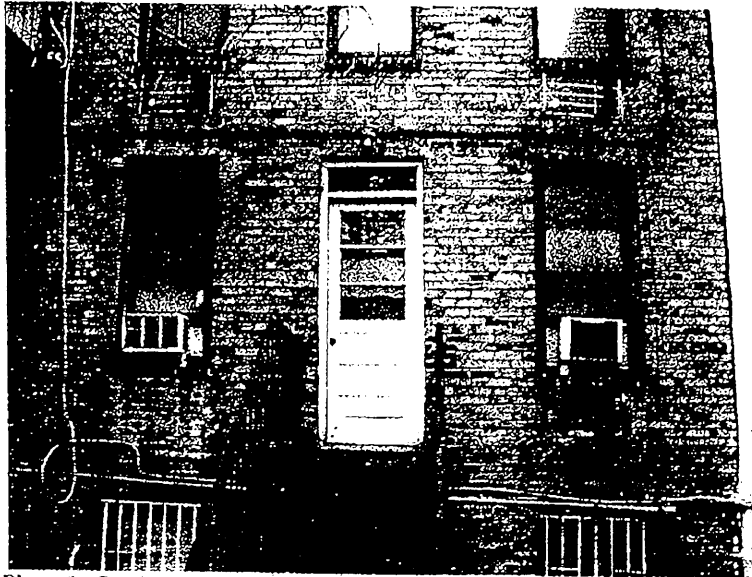
During excavations and underpinning operations at the garage, the southeast corner of 430 East 77<sup>th</sup> Street settled approximately 3 inches, causing severe damage to the building. The damage is evidenced by severe cracking of the exterior brick façade, interior wall tiles, masonry units, floors, walls, and ceilings. The damage is illustrated by photographs in Appendix B. Damage to the interiors of the apartment units is most severe on the ground floor apartments and less severe on the upper floors. However, damage to the interiors were observed in all apartments on the eastern side of the building (F and E units) up to and including the top floor. Damage to the exterior façade is most severe on the southern wall, specifically the southeast corner of the building. The eastern line of windows on the south wall are all "racked", individual bricks are sloped to the east with some bricks experiencing vertical cracking, and in many areas mortar between bricks has been cracked and is missing.

Photo 1. South wall looking North. Damaged bricks and "racking" of windows.

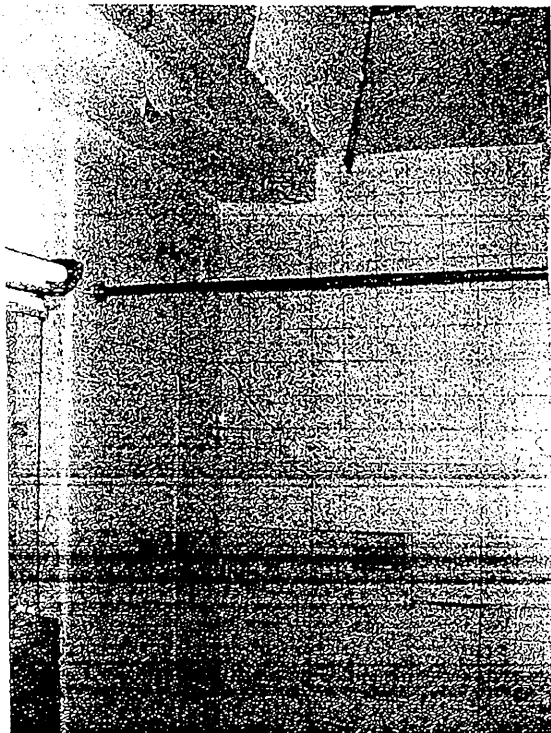
Photo 3. Ground floor, northeast apartment. Horizontal and vertical cracking of ceramic tile wall.

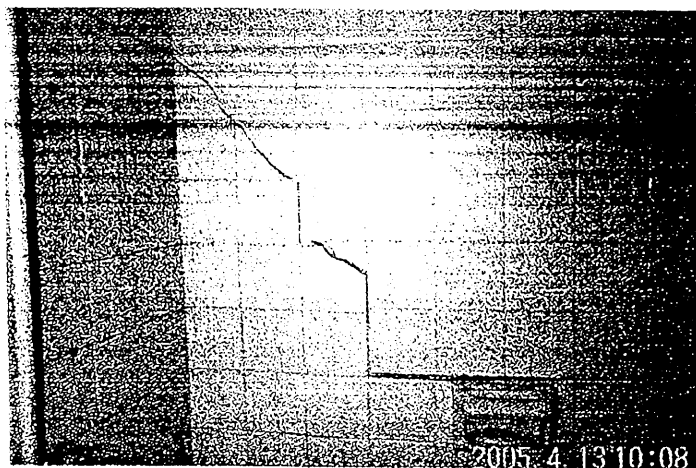
Photo 4. Ground floor, northeast apartment. Close-up of damaged ceramic tile wall.

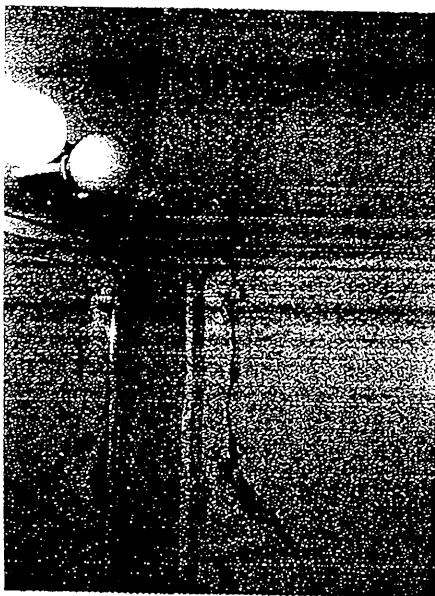
Photo 6. Ground floor, southeast apartment. Damaged sheet rock wall in bathroom.

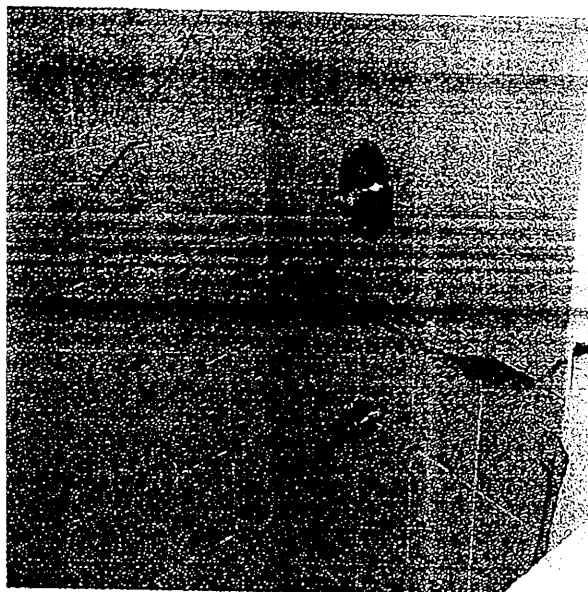
Photo 7. Ground floor, southeast apartment. Damaged ceramic tile wall in bathroom.

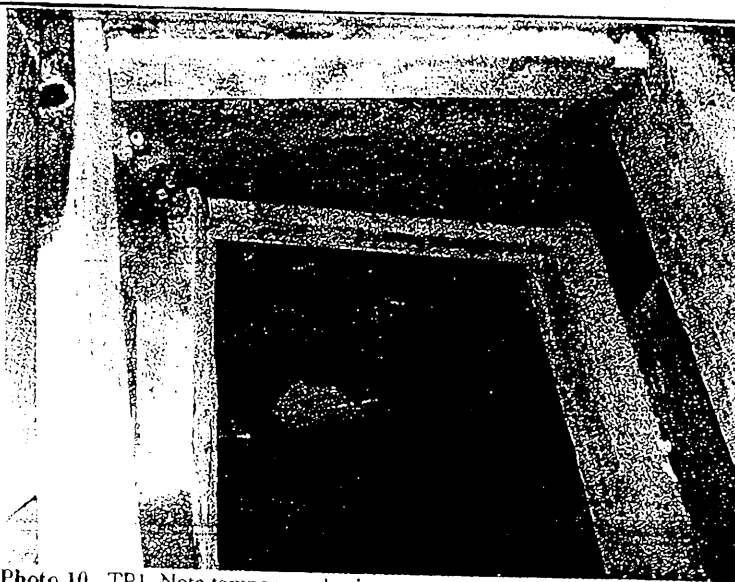
Photo 10. TP1. Note temporary shoring to support loose boulder foundation.

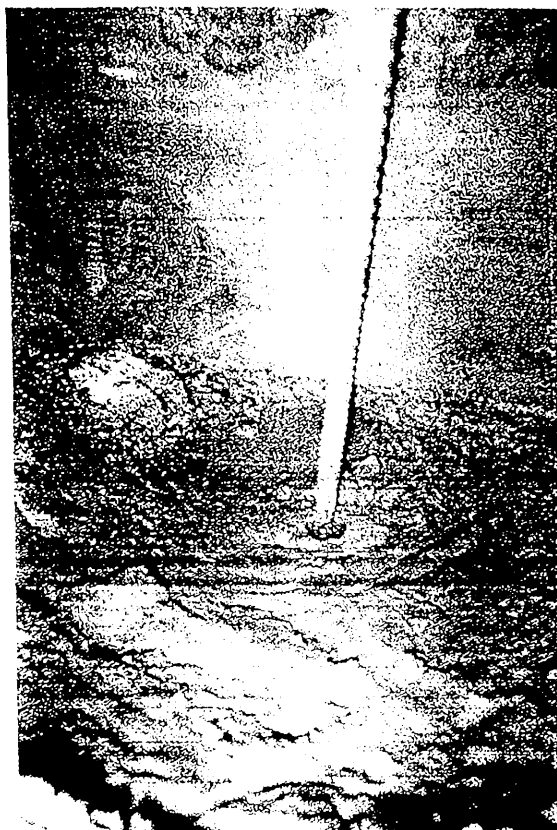
**Photo 18.** TP2. Close-up of bottom of underpinning with steel probe.
